Curly-leaf pondweed (*Potamogeton crispus*)

Post Herbicide Turion Survey

Balsam Lake – WBIC: 2620600

Polk County, Wisconsin

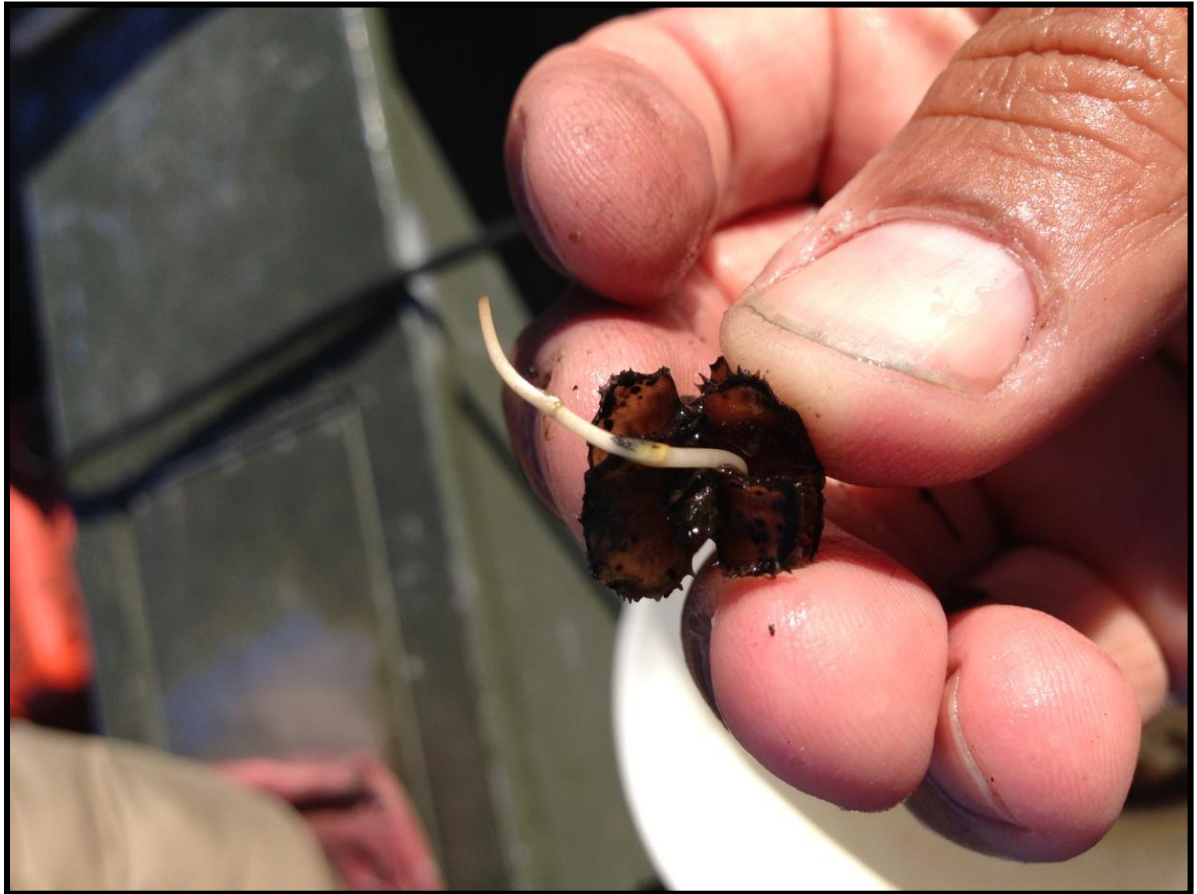
Figure 2: Germinating CLP Turion

Although Curly-leaf pondweed occasionally reproduces by seed, the vast majority of plants resprout from stiff overwintering buds called turions that are normally produced in number by the plants prior to their late June/early July senescence (Figure 2). After the pinecone-like turions germinate in late fall or early winter, plants continue to grow slowly under the ice. Following ice out, growth accelerates, and plants rapidly canopy allowing them a competitive advantage over slower growing native species (Capers 2005).

Research suggests approximately 50% of turions germinate in a growing season while the rest remain dormant until the following growing season when another 50% will germinate (Johnson 2012). Depending on the level of turions at a given location, and knowing that latent turions may be able to survive for over 5 years in the sediment, it may take several years of control to exhaust the “turion bank” (R. Newman – U of M unpublished data).

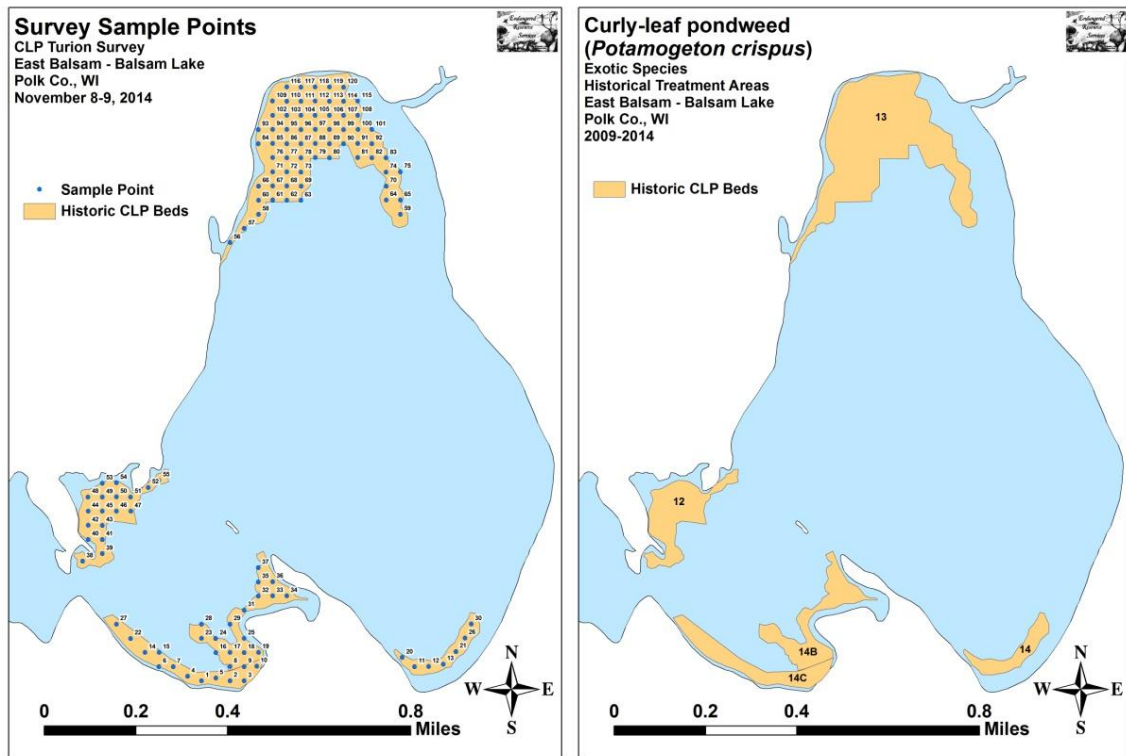
Figure 3: Turion Survey Sample Points in Historical Treatment Areas

After merging the 2014 treatment areas and the 2009 treatment of Bed 14C into a single shapefile, we used Hawth's Analysis Tools Extension to ArcGIS 9.3.1 to generate regular points at the rate of approximately 1.7 points/acre. This produced a 120 point sampling grid of which 18 were in Bed 12, 65 were in Bed 13, 7 were in Bed 14, and the remaining 30 were in the combined area of Beds 14B and 14C (Figure 3) (Appendix I).

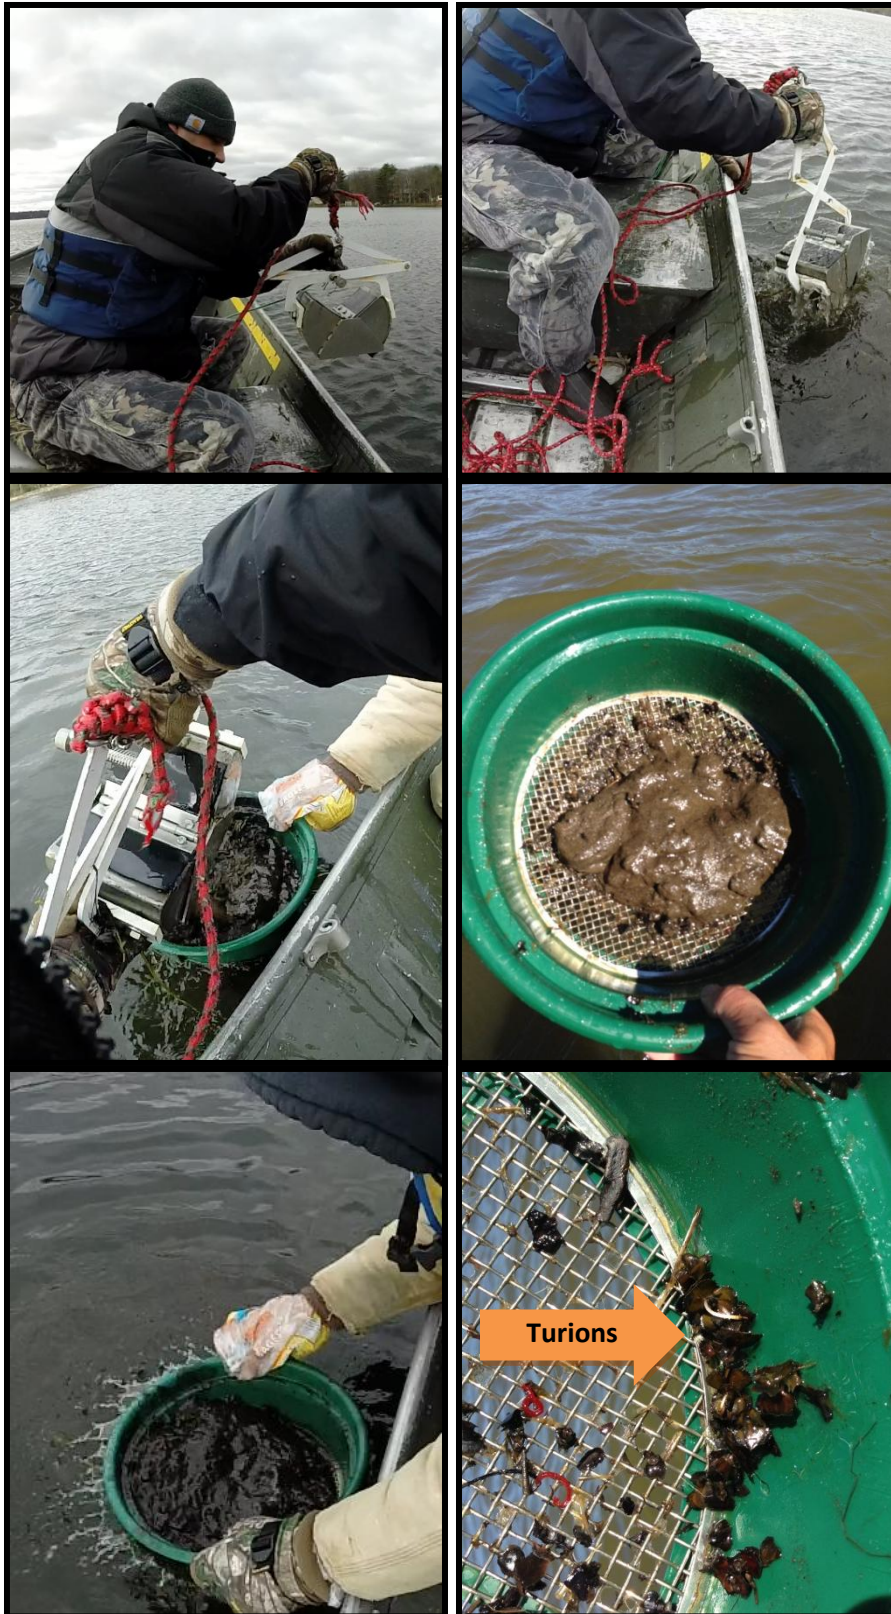
Figure 4: East Balsam Ponar Grab and Turion Sieving

During the surveys, we located each point with a handheld mapping GPS unit (Garmin 76CSx) and used a Petite Ponar dredge with a 0.0232m^2 (36in^2) sample area to take a bottom sediment grab from each side of the boat at each location. These samples were then rinsed in a fine sieve to separate out the sediment (Figure 4). Samples with high numbers of turions/levels of detritus were bagged for later analysis at which time we discarded all rotten turions, tallied all live turions, and multiplied the combined total live turions from the two samples by 21.53 to estimate turions/ m^2 at each location. This value gives an idea of how many CLP plants will germinate in an area in 2015.

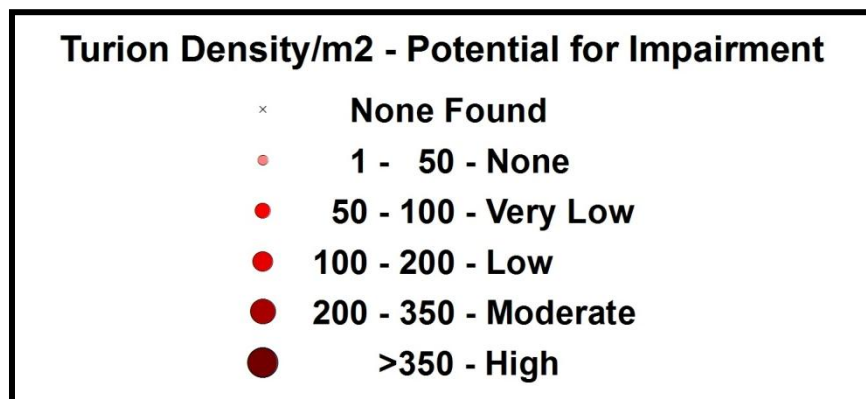
Figure 5: Predicted Navigation Impairment Based on Turion Density

Points at or above nuisance level: This value gives the number of survey sites within the study area that were above the predicted nuisance threshold (Figure 5). Research suggests that when the turion density is at or above 200/m², the following year's CLP growth has the potential to at least moderately impair navigation (Johnson 2012).

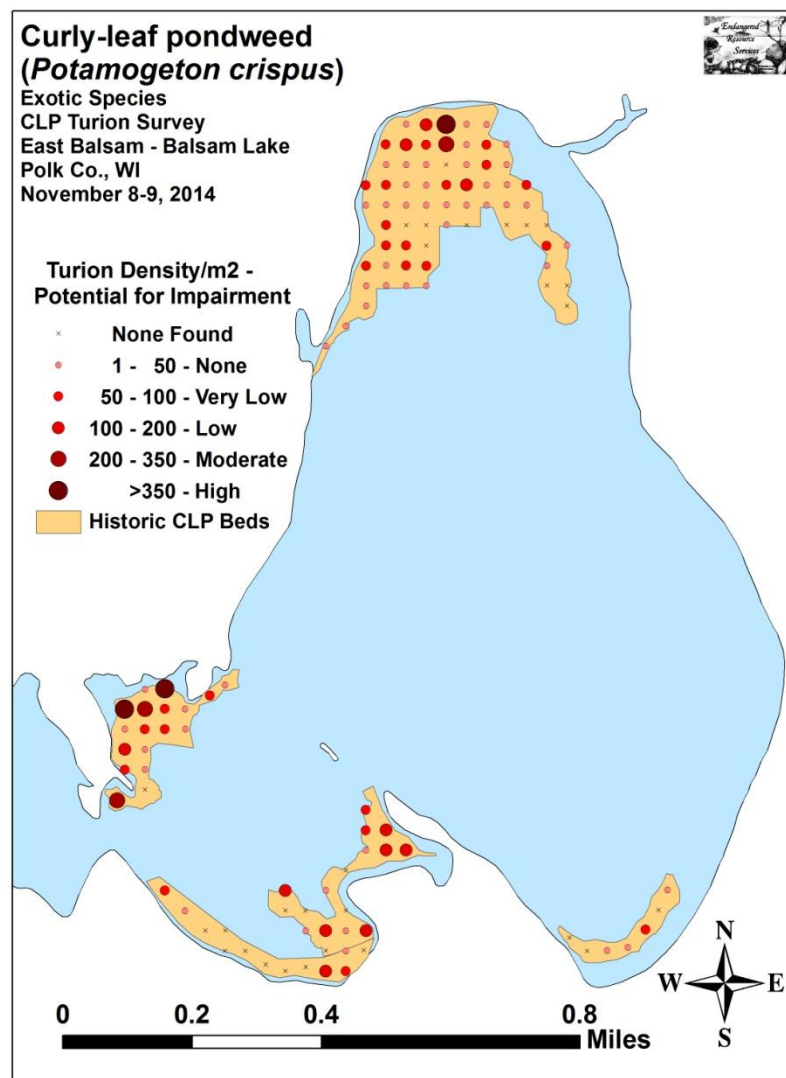
Figure 6: Fall CLP Turion Survey Density and Distribution

The November 8-9th survey revealed CLP turions were present throughout much of the treatment areas with 92 of 120 points having live turions (76.67%) (Figure 6) (Appendix II). Despite this, only 6 points (5%) suggested CLP growth in 2015 had the potential to exceed the nuisance threshold with densities >200 turions/m² (Table 1). When broken down by area, Bed 12 had the highest rate with over 22% of the bed projected to exceed this level. Bed 13 was the only other area with any nuisance points, and both of them were located at the very northern edge of the bed. All of the nuisance points were in areas with shallow water (<5 ft) that historically have also had extremely dense canopied CLP.

The overall mean turion density was 61.53 turions/m² which suggested that the average potential for impairment would be very low. Turion densities were somewhat variable with all standard deviations values being greater than the mean. However, only Bed 12 was more than 25% higher than the mean, and none were double the mean.

The turion survey suggests there will again be CLP throughout East Balsam Lake in 2015 with potential navigation issues in Bed 12 (northwest of the Big Narrows outlet to the main lake) and Bed 13 (north bay). If the BLPRD determines its goal is to further reduce CLP with an eye on future native plant restoration, it may be looking at another large scale treatment with the hope of getting basin-wide residual control. If they decide they would rather solely focus on minimizing navigation impairment, it appears they could be much more limited in scope.

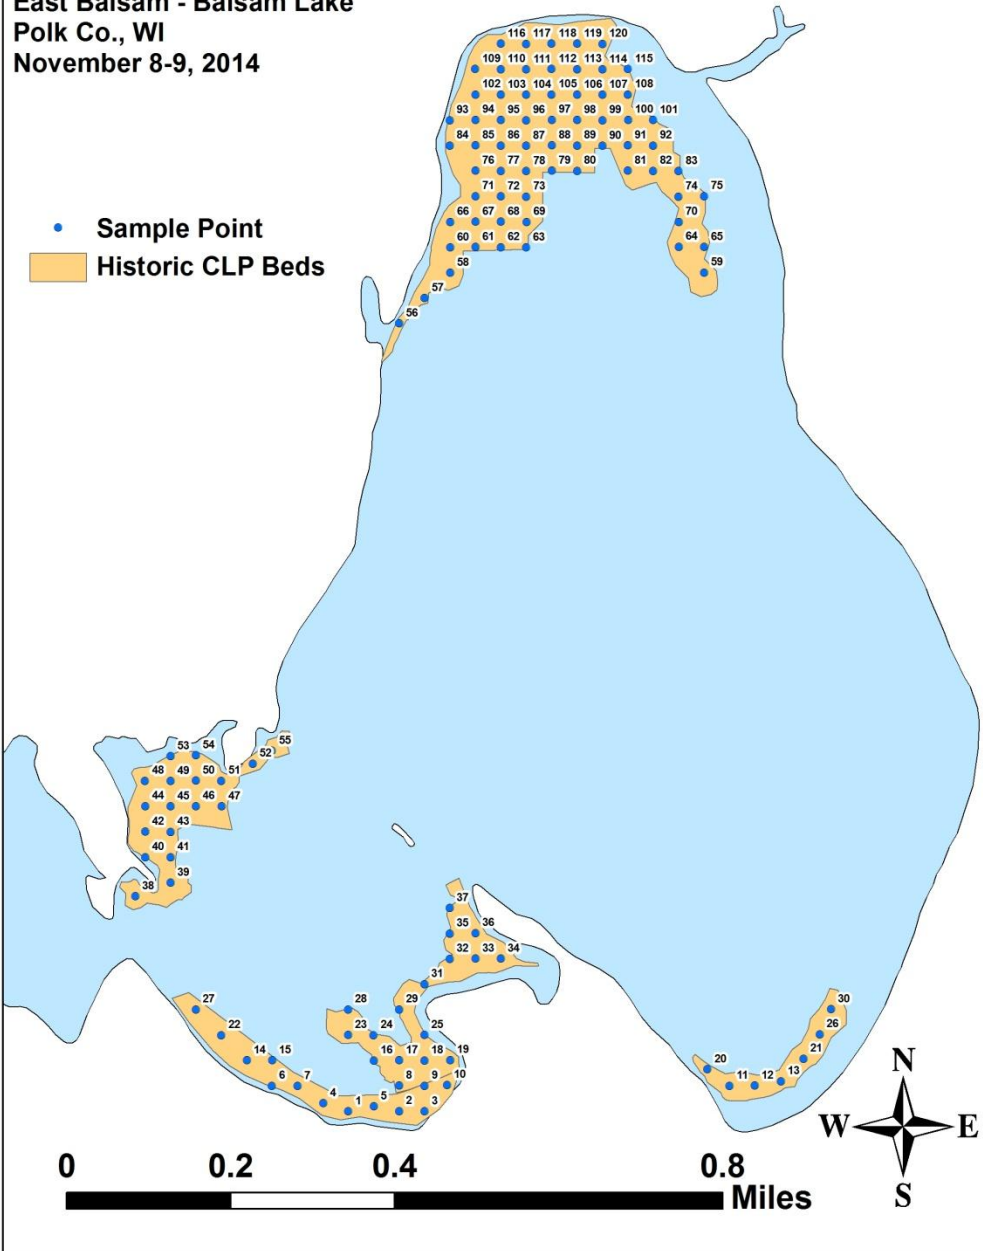
Appendix I: Survey Sample Points and Historic CLP Treatment Areas

Survey Sample Points

CLP Turion Survey

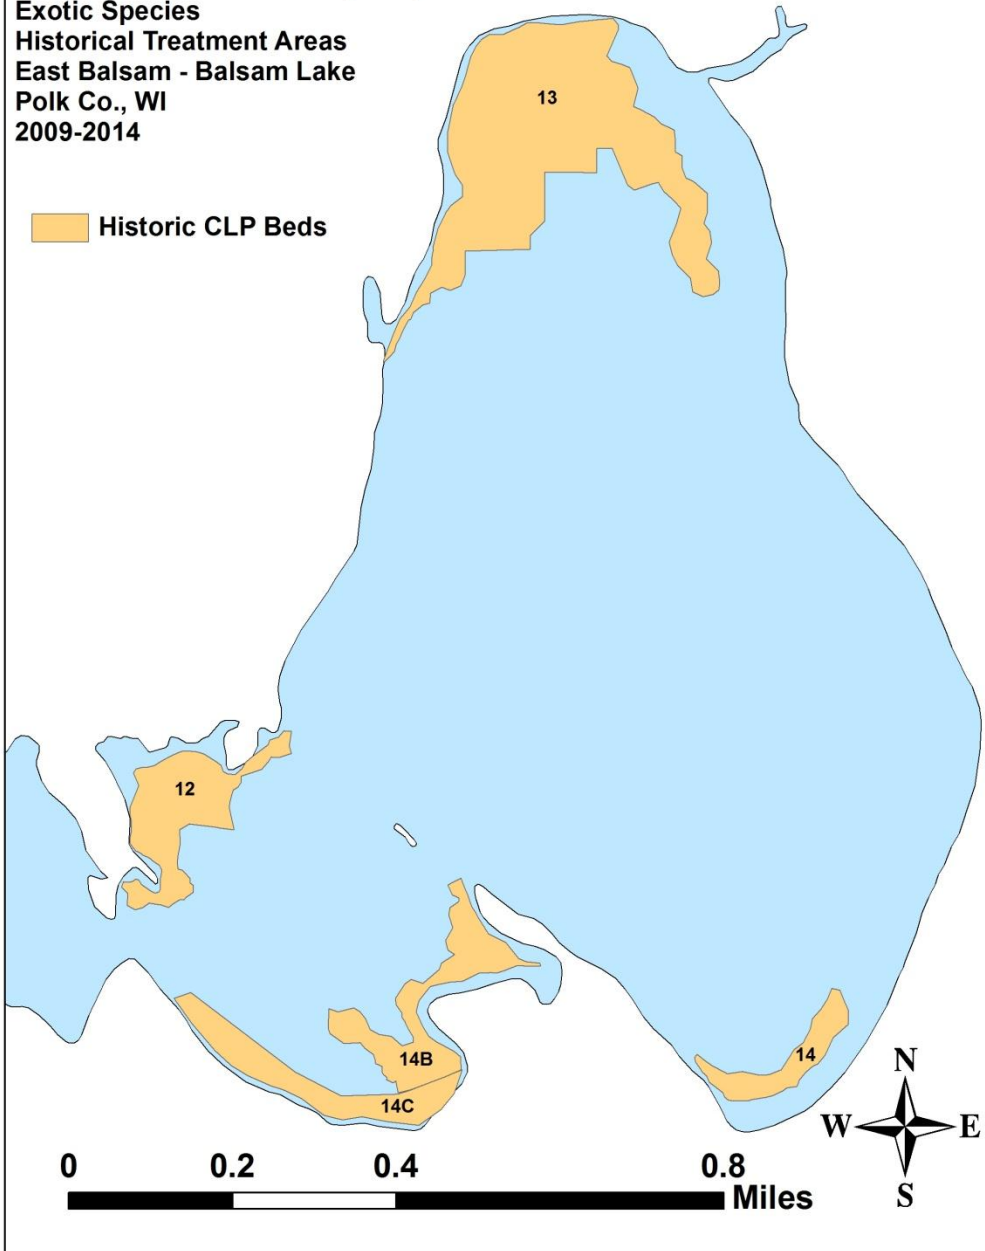
Exotic Species
Historical Treatment Areas
East Balsam - Balsam Lake
Polk Co., WI
2009-2014

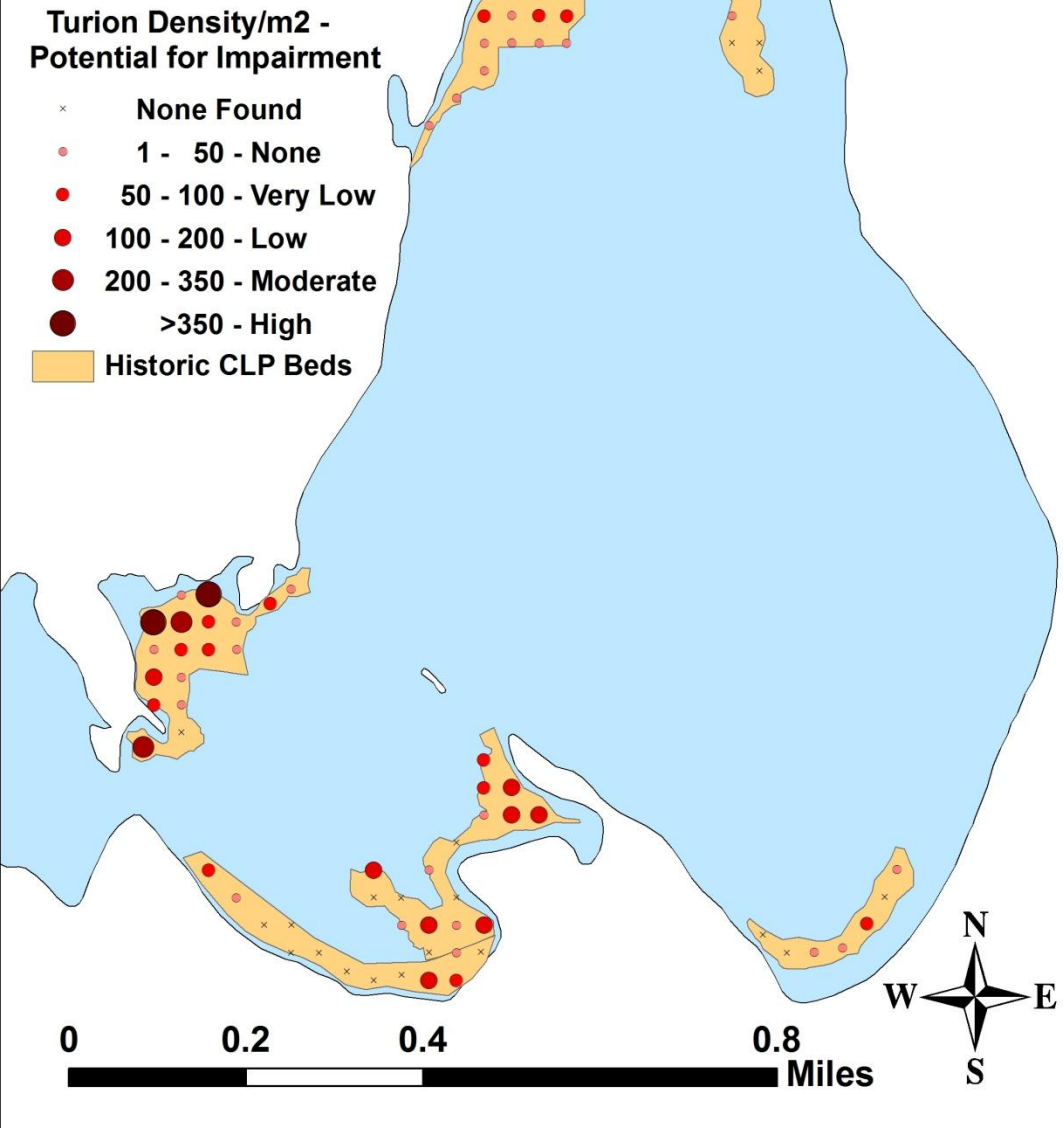
Appendix II: 2014 Fall CLP Turion Density and Distribution Map

Exotic Species
CLP Turion Survey
East Balsam - Balsam Lake
Polk Co., WI
November 8-9, 2014
