# **Boat Landing Exotic/Invasive Species Inspections and Shoreline AIS Survey Balsam Lake WBIC: 2620600 Polk County, Wisconsin**

Balsam Lake Protection and Rehabilitation District and the  
Wisconsin Department of Natural Resources – Grant ACEI21218

Endangered Resource Services, LLC  
Matthew S. Berg, Research Biologist  
St. Croix Falls, Wisconsin  
June-October, 2022

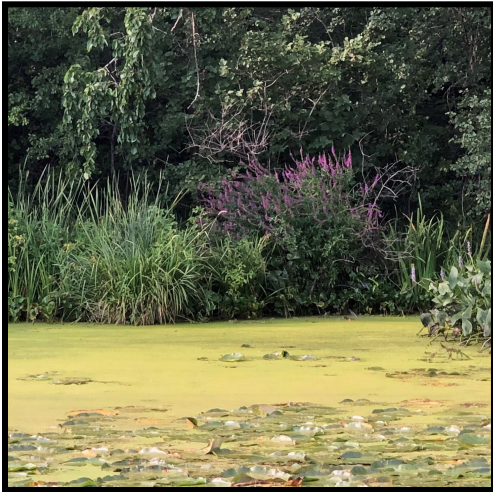
Purple loosestrife by the HWY 46 landing 8/22/22

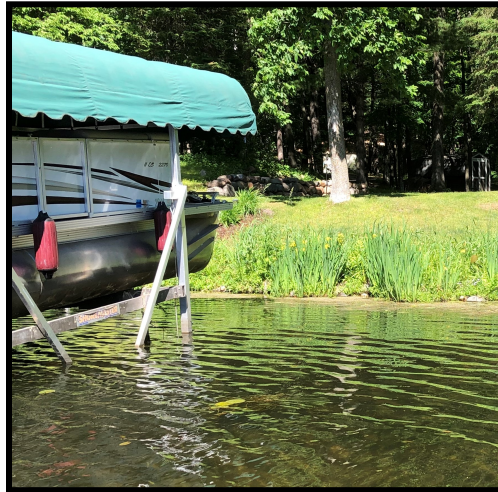
Yellow iris in the Mill Pond 6/17/22

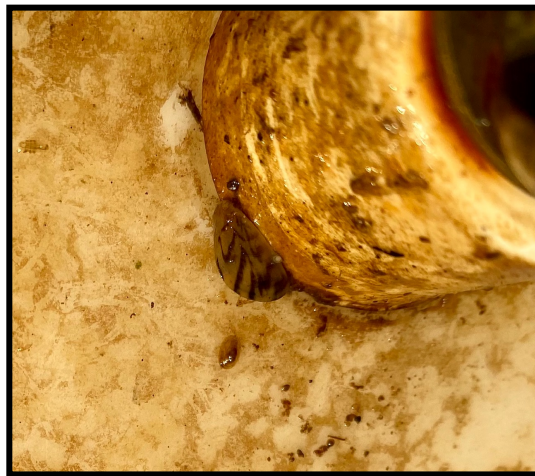
Zebra mussel on Forest Lake Circle sampler October 2022

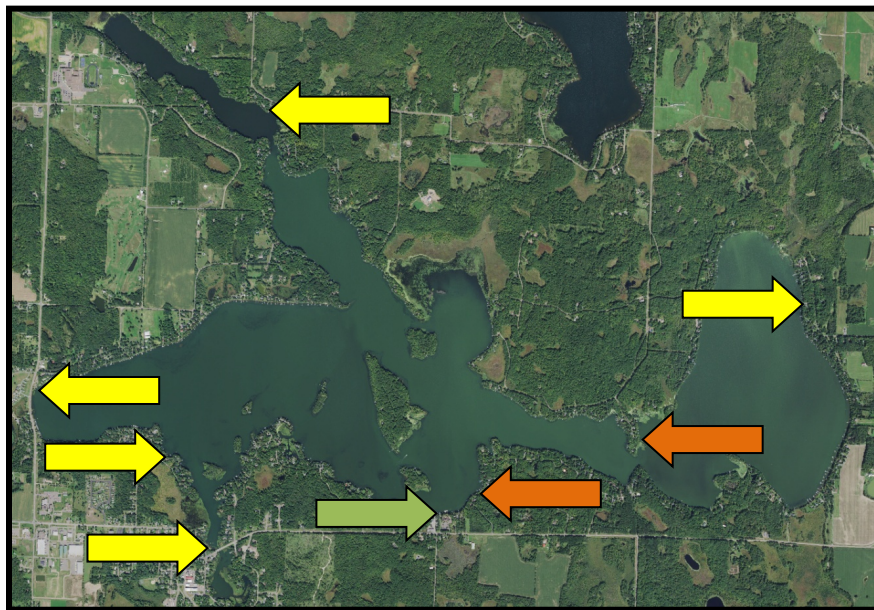
**Figure 2: Balsam Lake Landings**

Throughout the 2022 growing season, we conducted landing inspections at the five main public landings (HWY 46, Little Balsam, Idlewild, City Beach, and East Balsam – yellow arrows below), two unimproved public landings (Forest Lake Circle and Northeast of the Big Narrows – orange arrows below, and the private landing at Sunnyside Marina – green arrow below (Figure 2). Using three 100-150m parallel transects approximately 15, 30 and 45m from shore; we motored at idle speed looking for any evidence of Eurasian water-milfoil's (*Myriophyllum spicatum*) characteristic red growth top, or any other exotic/invasive plant species we might encounter. Once we had finished the three transects, we returned to our starting point using a stitch pattern that crossed back and forth over all three lines to look for any plants we may have missed between the transects.

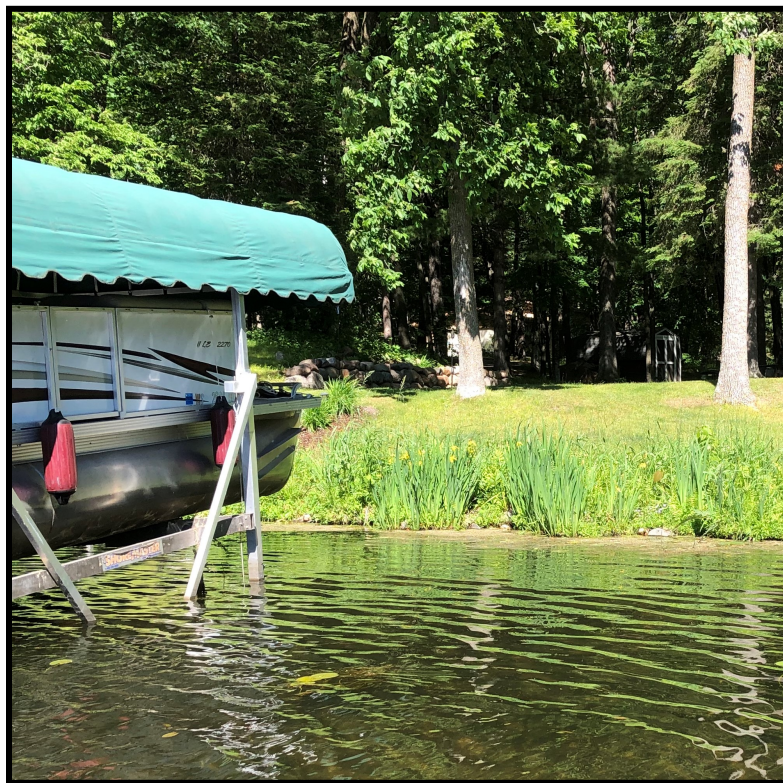
**Figure 3: Yellow Iris in the Mill Pond 6/17/22**

Yellow iris (YI) was first found on the lake in 2020 by the Polk County Land and Water Resources Department (PCLWRD). In 2021, we located and helped remove a significant stand at Ward's Resort as well as a handful of other clusters around the lake. Well established stands tend to form dense clusters of sword-like leaves and are easy to identify even when they are not in bloom. However, because newly-established plants can look very similar to the native Blue flag iris (*Iris versicolor*), we also indiscriminately trimmed seed heads and leaves off all iris plants found on the lake during our August 2021 full shoreline survey. In June 2022, we pro bono revisited these sites, and as expected, almost all of these plants turned out NOT to be YI. In the few places we did find YI, we removed as much of the plants as we could. The only place we did not remove plants/seed heads was in the Mill Pond where this species is spreading rapidly, and it would have taken considerable time and effort to dig out what is currently there (Figure 3).

Top clipping iris along the lake didn't kill many plants, but it did limit further dispersal in 2022. During our CLP bed mapping survey in the spring of 2023, we will again revisit locations that have had Yellow iris on the lake, and continue to remove them where possible. We again encourage the BLPRD to consider placing a "wanted poster" in the spring issue of the *Dock Side* to encourage property owners to remove plants along their shoreline if they find them in June when they are easy to identify.

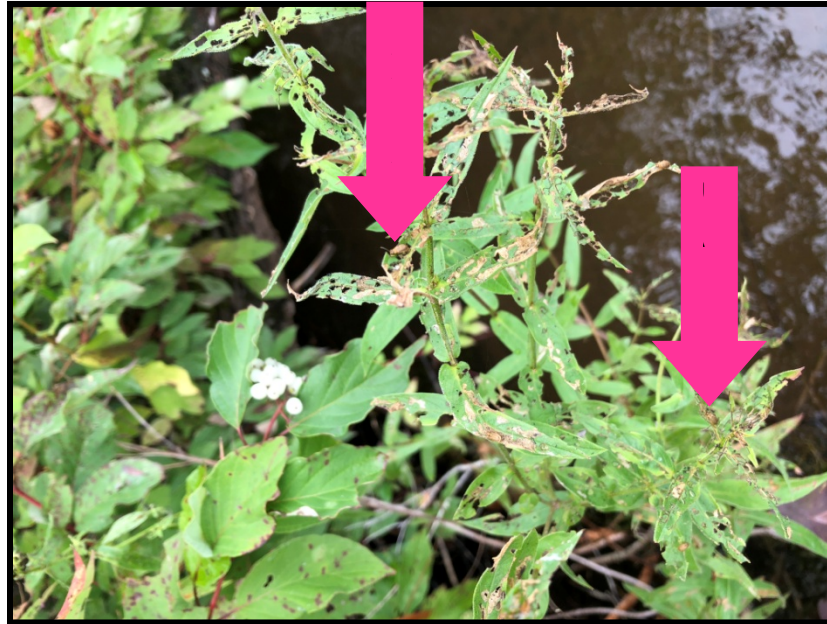
**Figure 4: Purple Loosestrife with Adult Beetles/Larvae/Holes in Leaves**

We again found Purple loosestrife (PL) near the village beach landing area and in Idlewild Bay. Most of the plants observed in these areas again had *Galerucella* beetles – a natural biocontrol that specializes in eating loosestrife. First released in 2014, these insects have done a highly effective job at controlling PL in this area since that time (Figure 4).

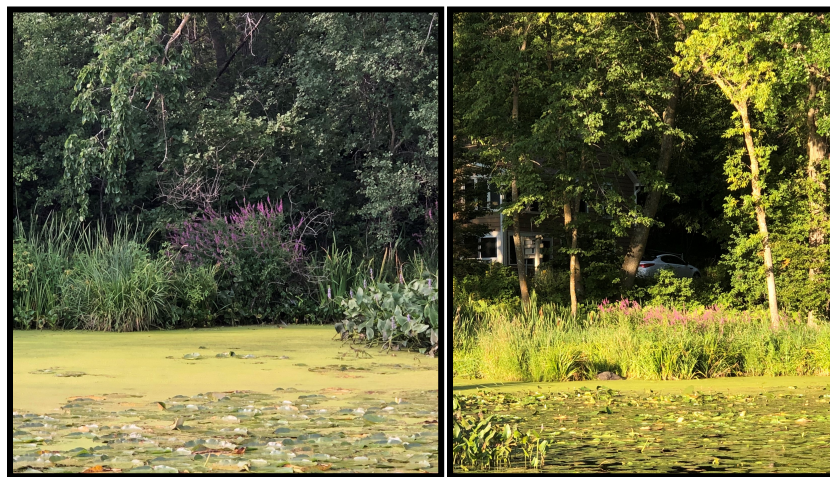
**Figure 5: Purple Loosestrife at the HWY 46 Landing and in City Bay**

Away from City Bay, we again removed several large plants at the HWY 46 landing (Figure 5). We also revisited places where we had dug out plants in East Balsam in 2021. We were pleased to find they remained loosestrife free with the exception of the sizable stand that is growing in the cattails just across the road from the northwest finger bay.

The newly discovered population on East Balsam Lake's northwest shoreline bay is large enough to sustain a beetle population. Ideally, the PCLWRD will again work with the BLPRD to raise and release beetles at this location to prevent further spread. Similar to Yellow iris, a reminder for BLPRD members to be on the lookout for loosestrife in July/August and remove it immediately if they find it would help slow the spread of this beautiful, but highly invasive wetland species.

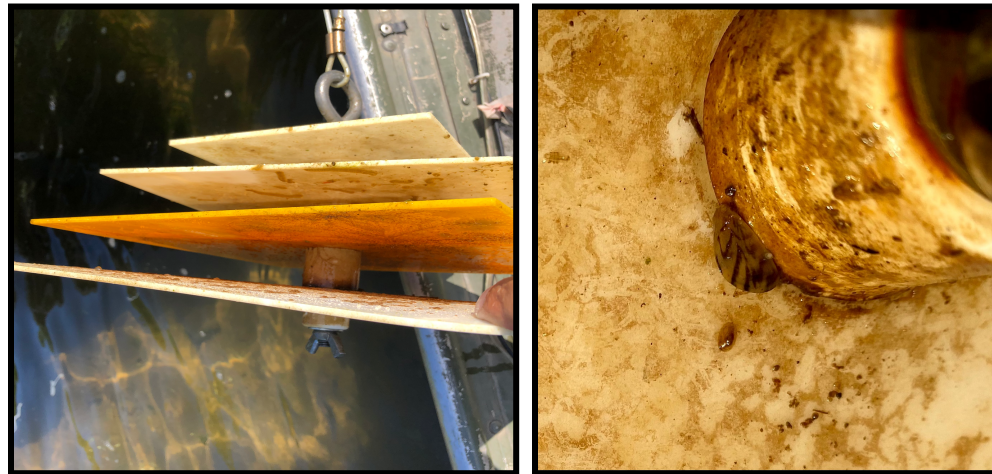
**Figure 6: Zebra Mussel Samplers 7/18/22 and 10/18/22**

Despite the discovery of a Zebra mussel on a rock by a lake resident in mid-June 2022 just southeast of the Little Narrows, we found no evidence of ZM on any of the plastic samplers during any of our surveys. However, WDNR and PCLWRD confirmed positive veliger tows and several additional adults found on rocks around the central islands. Ultimately, the only ZM found on the samplers turned up at the Forest Lake Circle site when it was removed in late October (Figure 6).

Zebra mussels unfortunately appear to be well established in the lake, and educating lake residents and visitors to be careful about not transporting them to other area lakes now becomes a priority. During our August and September surveys, we learned several CBCW landing monitors had not yet heard that ZM had been discovered on the lake. Making sure they know so they can give appropriate updates to watercraft users will likely be an important starting point in disseminating this information to the general public.
