LANDOWNER: Fred & Merna Salmon

LOCATION: 1713 S Balsam Lake Court

#### PROJECTS:

- Infiltration Pit
- Downspout Burial
- Native Hillside Plantings

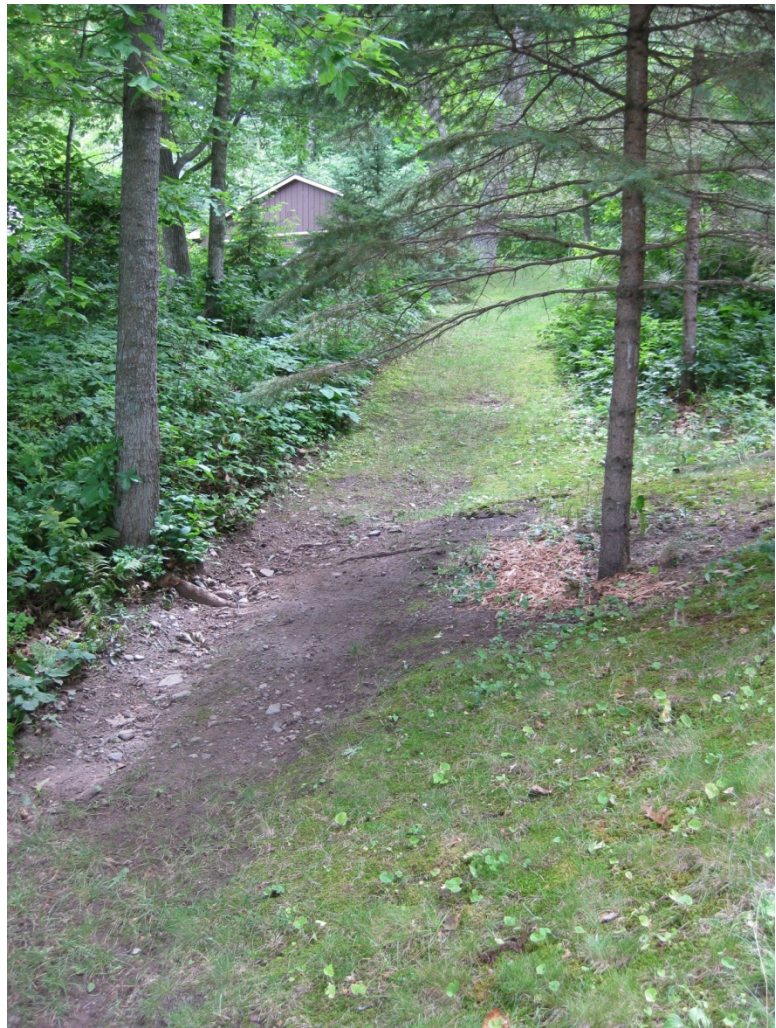
BEFORE

ISSUE: The property is located on a hillside between the road and the lake. During rain events, all the water from the road, parking area, and garage runs down the tote road on their property. This causes severe erosion and washout along the tote road, as well as pooling of water in the lower, flatter areas of the yard.

SOLUTION: An infiltration pit was constructed to capture the rainwater and allow it to soak into the soil. The pit itself was dug into a vegetated area in the upper portion of the yard. Aquablox—a matrix of hollow plastic cubes—were placed inside the pit and wrapped in filter fabric to prevent sediment from entering and reducing the holding capacity of the blocks. Water is then directed into the pit by means of a large drain-type structure placed on the road and connected to the blocks via draitile. Additionally, repairs were made to the tote road to prevent further erosion.

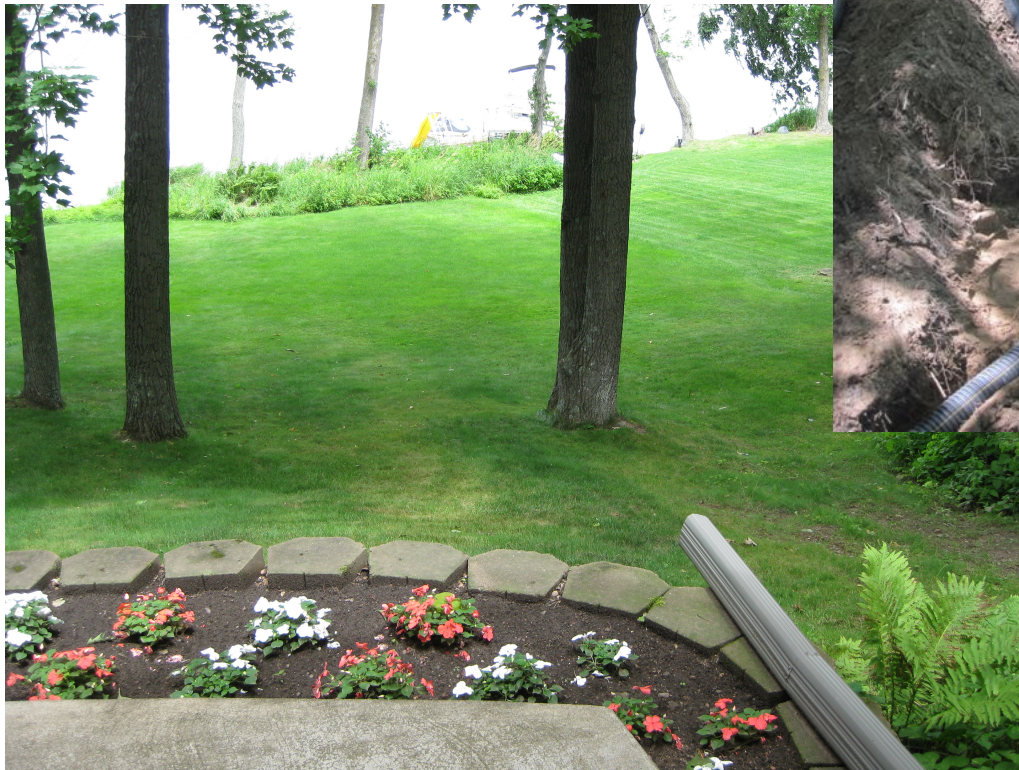
BEFORE

ISSUE: The house is fitted with gutters, but the downspouts are directed down the hill and towards the lake. Due to the amount of water that is discharged from the downspouts, there was significant erosion occurring, especially at the output on the northeast corner of the house. As a result, it was a real challenge to grow and mow the lawn, and attempts at plantings were unsuccessful. The water was also pooling in the low areas of the yard where the clayey/rocky soils didn't allow it to soak into the soil.

SOLUTION: The downspout was buried and now drains underground.

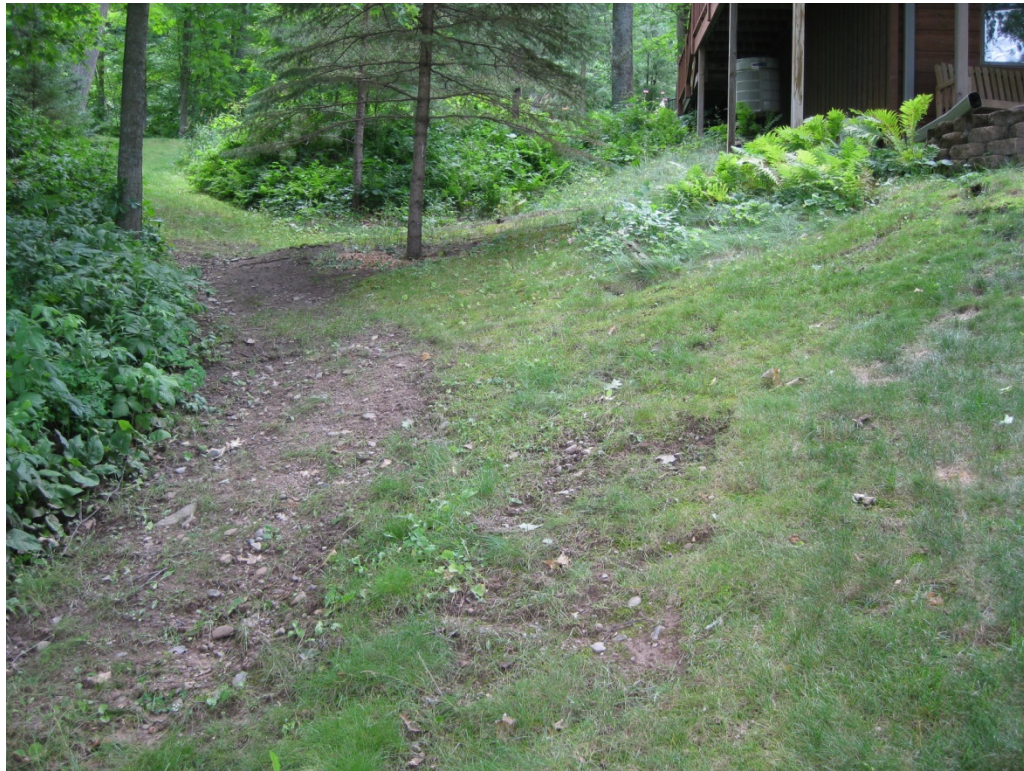
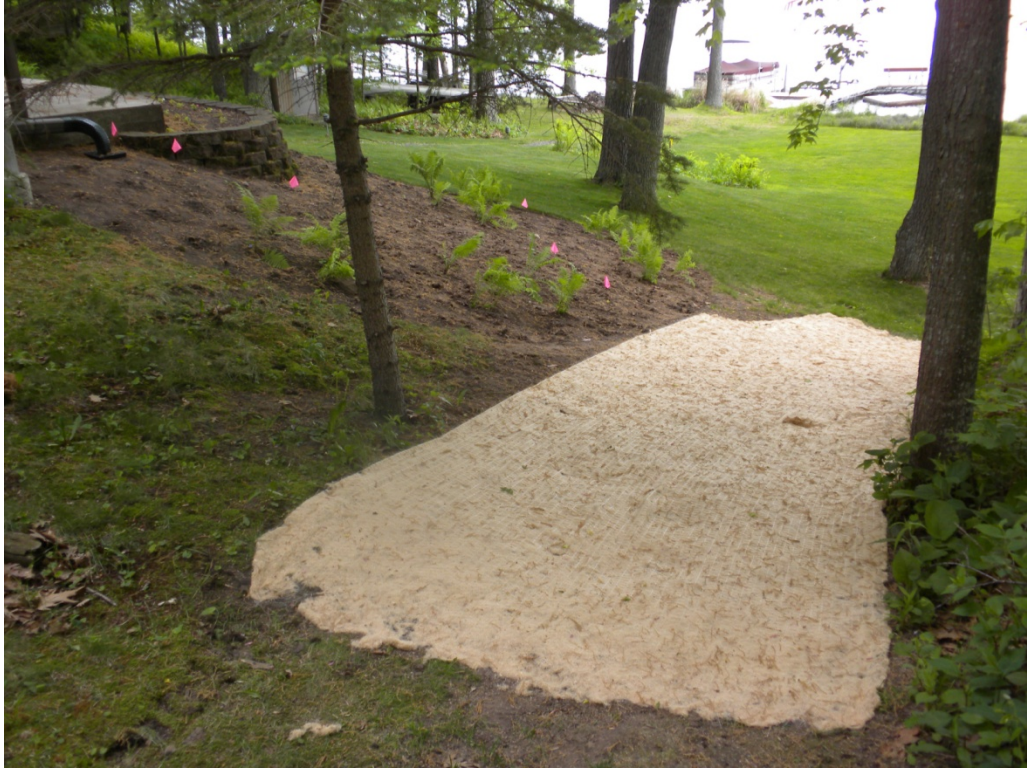
BEFORE

ISSUE: The excessive amount of water flowing down the yard—both from the tote road and the downspouts—was causing erosion of the hillside.

SOLUTION: Native plants and shrubs were planted on the hillside. Their deep root systems should serve to anchor the soil in place and encourage infiltration of any surface runoff. New grass was seeded at the base of the tote road. A netless erosion control blanket was used to keep the seeds in place until the lawn is established.
