Curly-leaf Pondweed (*Potamogeton crispus*)

Fall Turion Survey

City Bay - Balsam Lake – WBIC: 2620600

Endangered Resource Services, LLC
Matthew S. Berg, Research Biologist
St. Croix Falls, Wisconsin
October 14, 2023

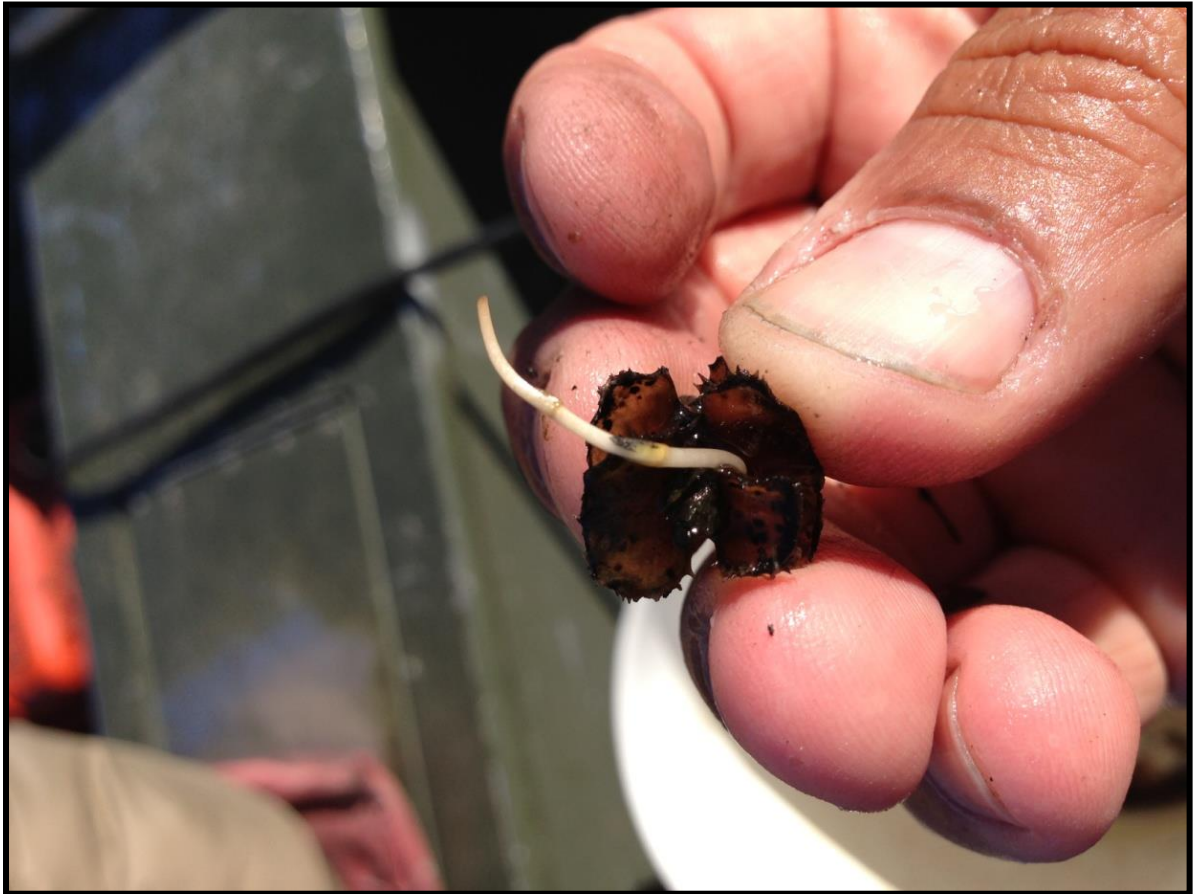
Figure 2: Germinating CLP Turion

Although Curly-leaf pondweed occasionally reproduces by seed, the vast majority of plants resprout from stiff overwintering buds called turions that are normally produced in number by the plants prior to their late June/early July senescence (Figure 2). After the pinecone-like turions germinate in late fall or early winter, plants continue to grow slowly under the ice. Following ice out, growth accelerates, and plants rapidly canopy allowing them a competitive advantage over slower growing native species (Capers 2005).

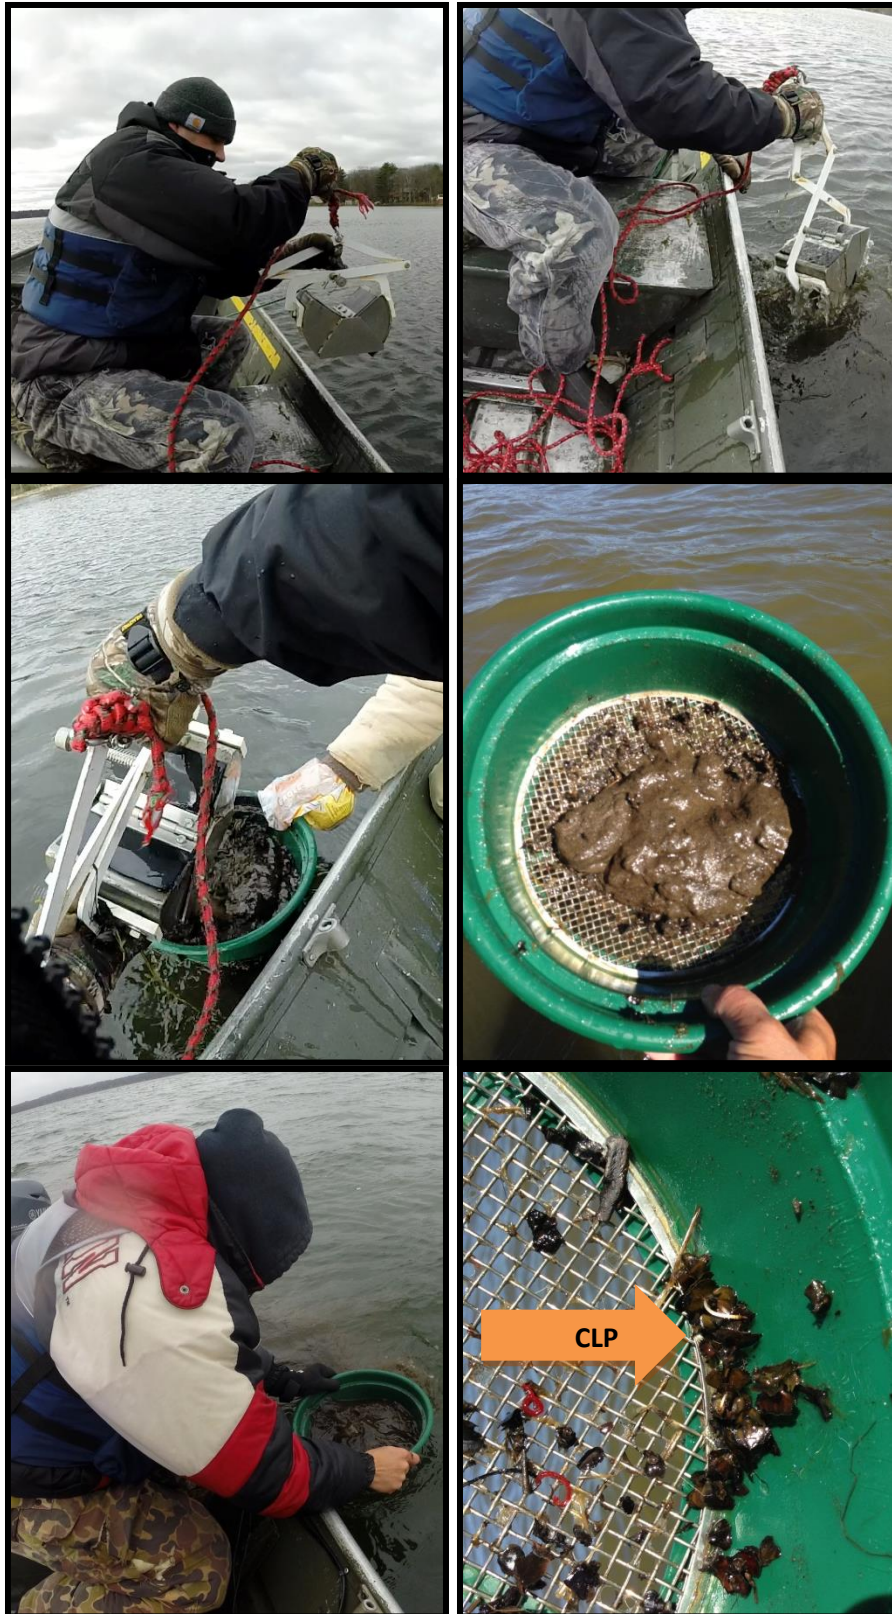
Figure 4: Ponar Grab and Turion Sieving

During the surveys, we located each point with a handheld mapping GPS unit (Garmin 76CSx) and used a Petite Ponar dredge with a 0.0232m^2 (36in^2) sample area to take a bottom sediment grab from each side of the boat at each location. These samples were then rinsed in a fine sieve to separate out the sediment (Figure 4). Samples with high numbers of turions or significant amounts of detritus were bagged for later analysis; at which time we discarded all rotten turions, tallied all live turions, and multiplied the combined total live turions from the two samples by 21.53 to estimate turions/ m^2 at each location. This value gives an idea of how many CLP plants will germinate in an area during the following growing season.
