Boat Landing Exotic/Invasive Species Inspections and Shoreline AIS Survey Balsam Lake WBIC: 2620600 Polk County, Wisconsin

Endangered Resource Services, LLC
Matthew S. Berg, Research Biologist
St. Croix Falls, Wisconsin
June-October, 2024

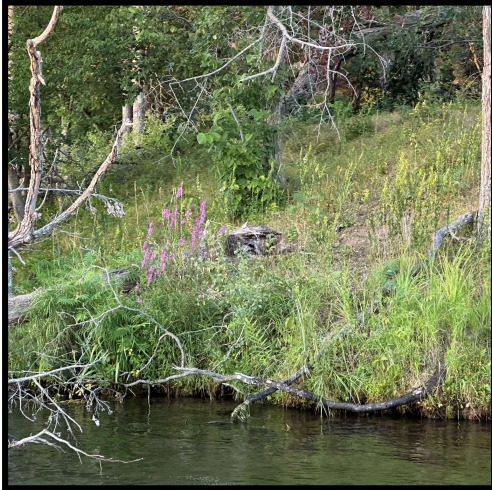
Purple loosestrife on First Island 8/10/24

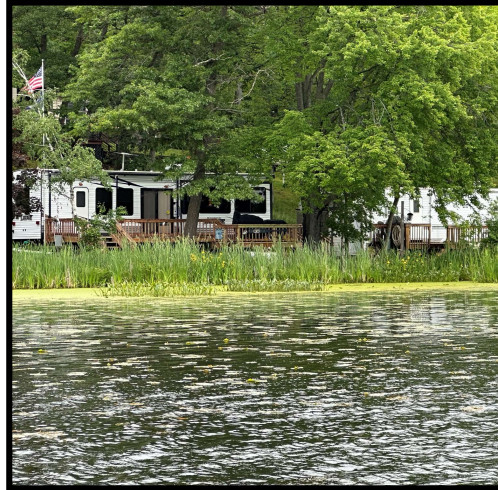
Yellow iris near the HWY 46 Landing 6/11/24

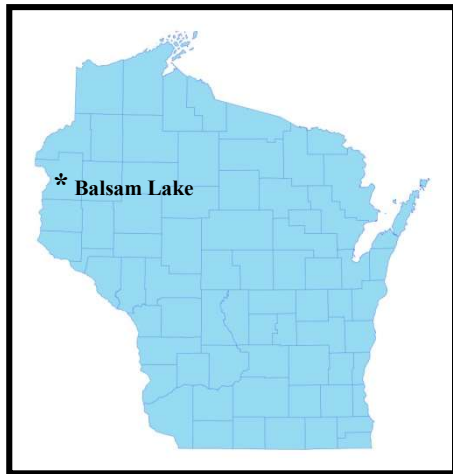
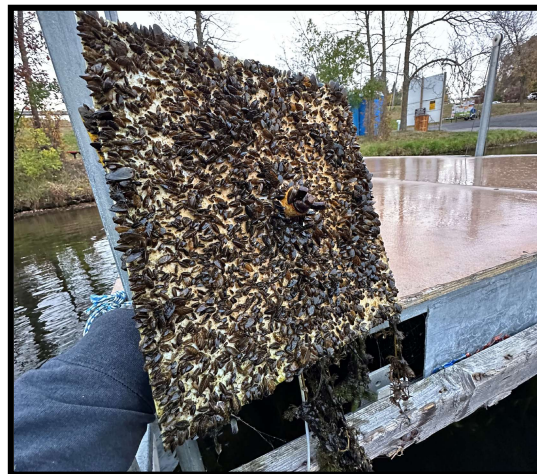
Zebra mussels covering the HWY 46 sampler 10/19/24

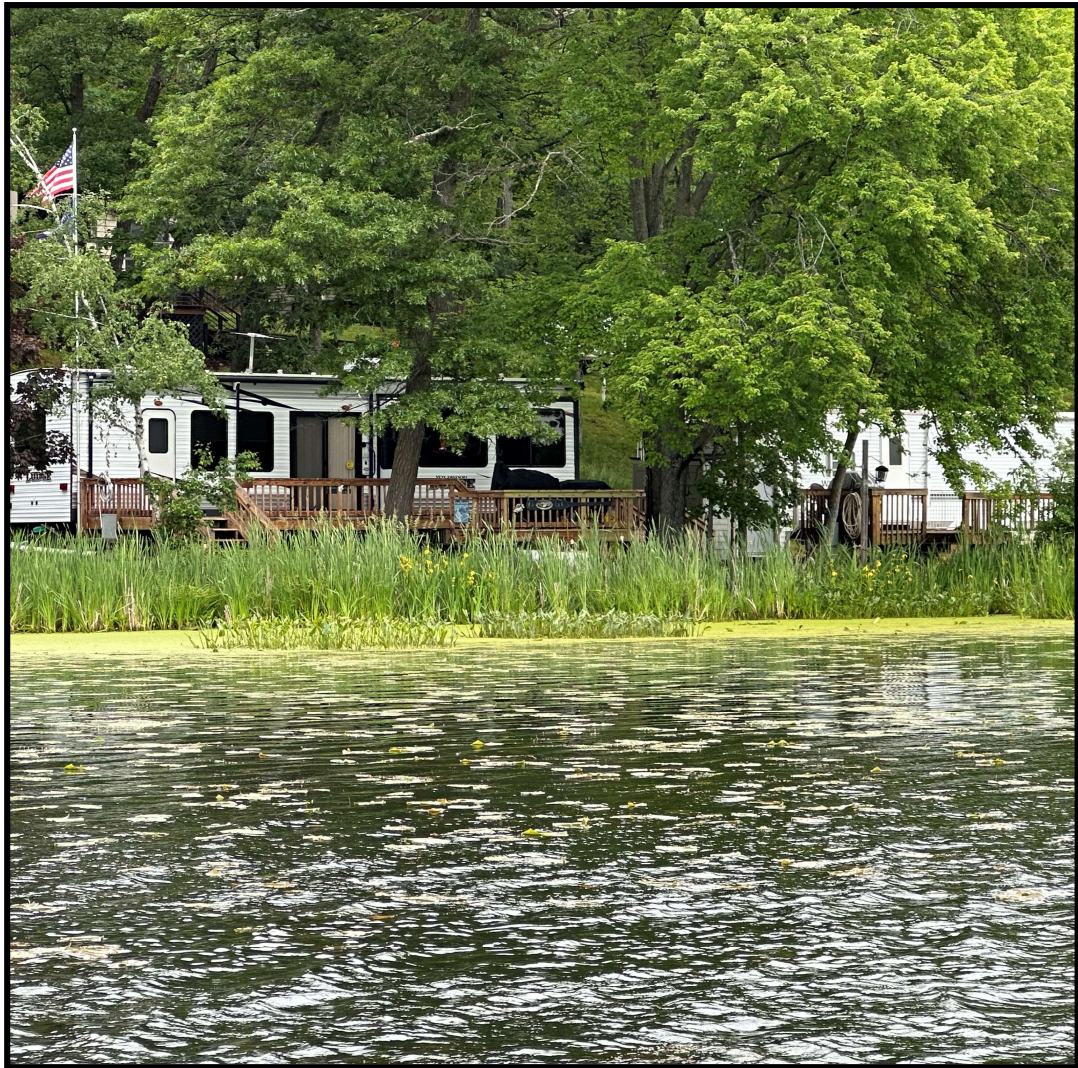
Figure 3: Yellow Iris Near HWY 46 – 6/11/24

Yellow iris (YI) was first found on the lake in 2020 by the Polk County Land and Water Resources Department (PCLWRD). In 2021, we located and helped remove a significant stand at Ward's Resort as well as a handful of other clusters around the lake. Since then, we have continued to remove seed heads on all plants found except in the Mill Pond and near HWY 46 where the species is spreading rapidly, and it would have taken considerable time and effort to dig out what is currently there (Figure 3).

Top clipping iris along the lake didn't kill many plants, but it did limit further dispersal in 2024. During our CLP bed mapping survey in the spring of 2025, we will again revisit locations that have had Yellow iris on the lake, and continue to remove them where possible. However, it is likely time for the BLPRD to consider chemical treatment near the HWY 46 Landing and in the Mill Pond to contain the aggressive spread of this species in those areas as it's quickly becoming more than private landowners will likely be able to contain on their own. Elsewhere, the plants continue to be rare so it's likely reasonable to continue having private individuals monitor their own shorelines. To facilitate this, we again encourage the BLPRD to consider placing a "wanted poster" in the spring issue of the *Dock Side* to explain to residents how to remove plants along their shoreline if they find them in June when they are easy to identify.

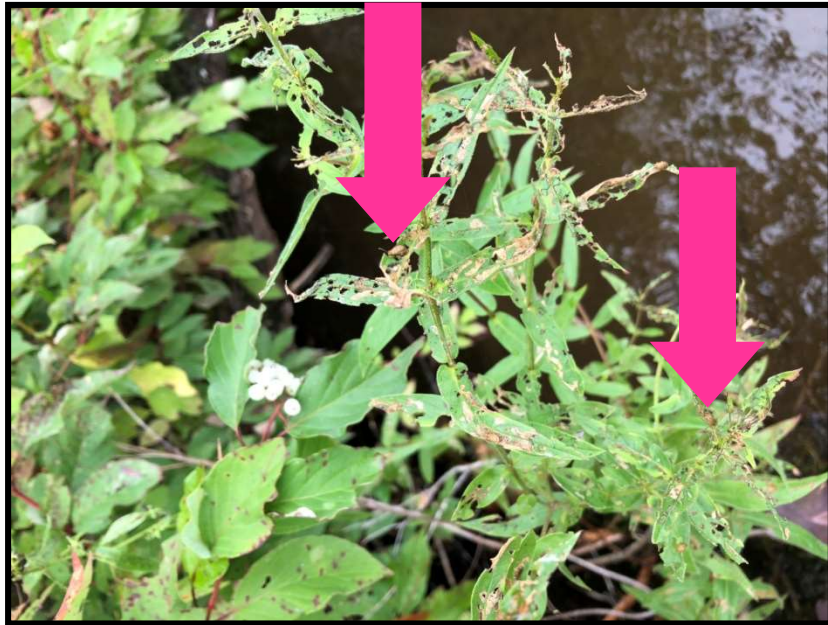
Figure 4: Purple Loosestrife with Adult Beetles/Larvae/Holes in Leaves

We again found Purple loosestrife (PL) near the village beach landing area and in Idlewild Bay. Most of the plants observed in these areas again had *Galerucella* beetles – a natural biocontrol that specializes in eating loosestrife. First released in 2014, these insects have done a highly effective job at controlling PL in this area since that time (Figure 4).

Similar to Yellow iris, a reminder for BLPRD members to be on the lookout for loosestrife in July/August and remove it immediately if they find it would help slow the spread of this beautiful, but highly invasive wetland species.

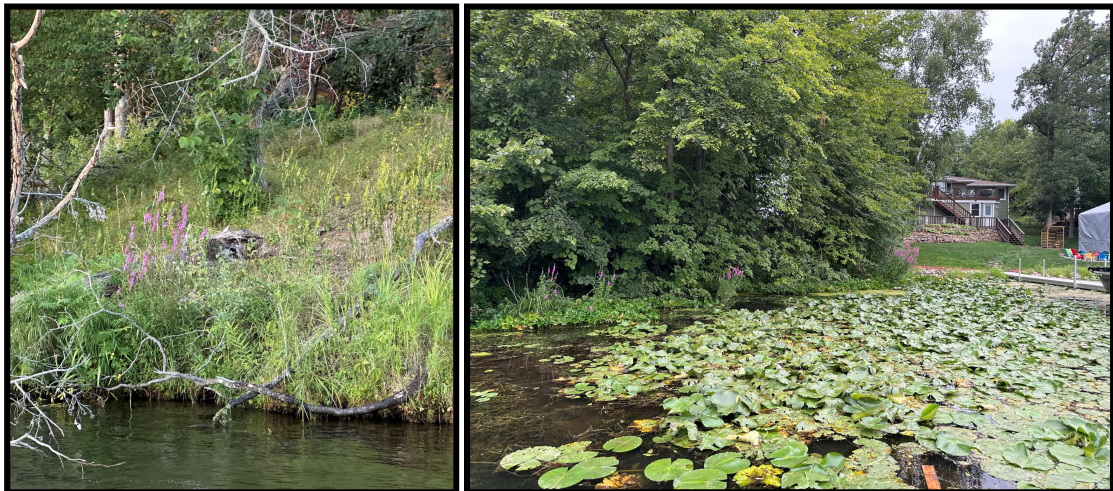
Figure 5: Purple Loosestrife on First Island and in City Bay

Away from City Bay, we again removed several large plants at the HWY 46 landing and a few scattered plants on First Island (Figure 5). We also revisited places where we had dug out plants in East Balsam in 2021. We were pleased to find they remained loosestrife free with the exception of the sizable stand that is growing in the cattails just across the road from the northwest finger bay.

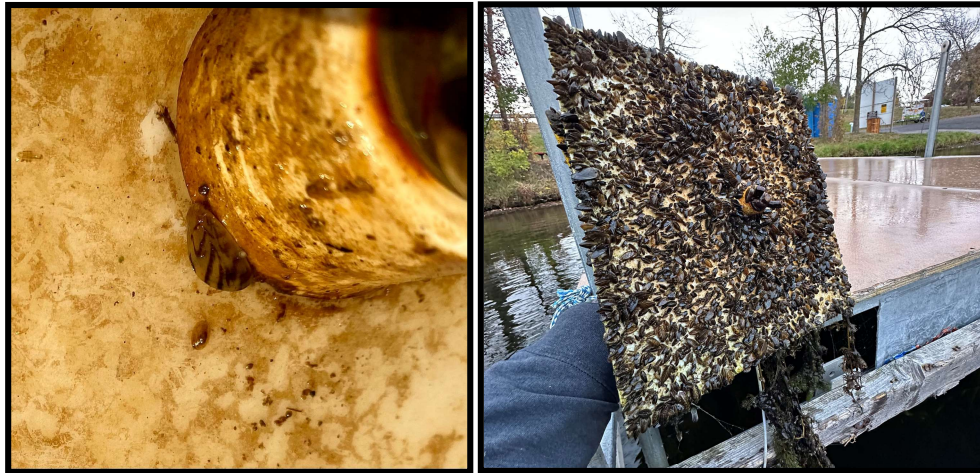
Figure 6: Zebra Mussel Sampler at Forest Circle – 10/18/22 and HWY 46 – 10/19/24

In 2022, the only evidence of Zebra mussels on a sampler was a single individual found at the Forest Circle site when it was removed in late October. However, in 2023 and 2024, ZM were found on each sampler at each location. Coverage was especially heavy at HWY 46 (Figure 6).

Zebra mussels are now well established in the lake, and educating lake residents and visitors to be careful about not transporting them to other area lakes now becomes a priority. The signs placed at the landings and the increased awareness of the lake's Clean Boats/Clean Waters monitoring staff are two important steps the BLPRD has taken to disseminate this information to the general public.
