LANDOWNER: Joel & Sandy Dunnette

LOCATION: Forest Circle

PROJECT: Rain Gardens (3)

PROJECT: Rock infiltration area
AREA: Approximately 78 square feet

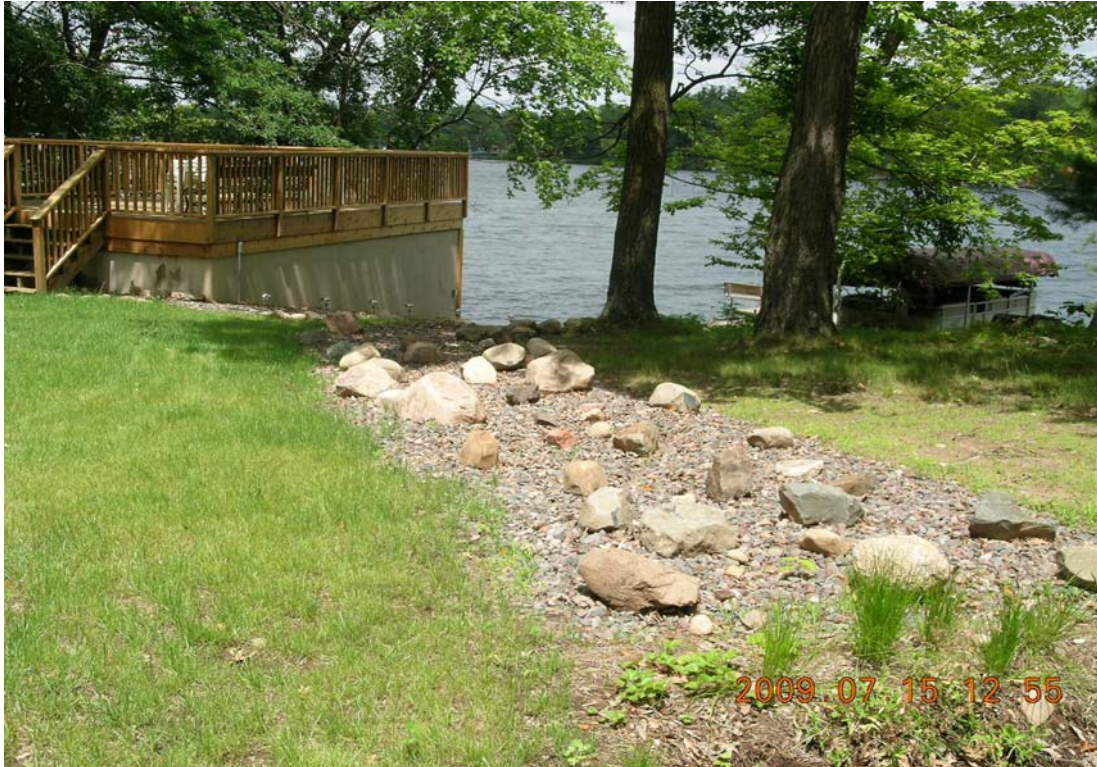
ISSUE: When we were contacted, construction of the house had just been completed. The water from the house's roof drains to downspouts, whose output was directed towards the lake. Water from the driveway was also flowing around the house and across the yard to the lake. The landscaping was completely unfinished, so the sandy soil was at risk for erosion.

SOLUTION: A series of 3 rain gardens was installed. The first was on the street side of the house to collect the water from the driveway and one of the downspouts. The other two gardens are located on the lake side of the house where they collect water from two additional downspouts. Rock overflows were also constructed to encourage excess water to infiltrate the soil.

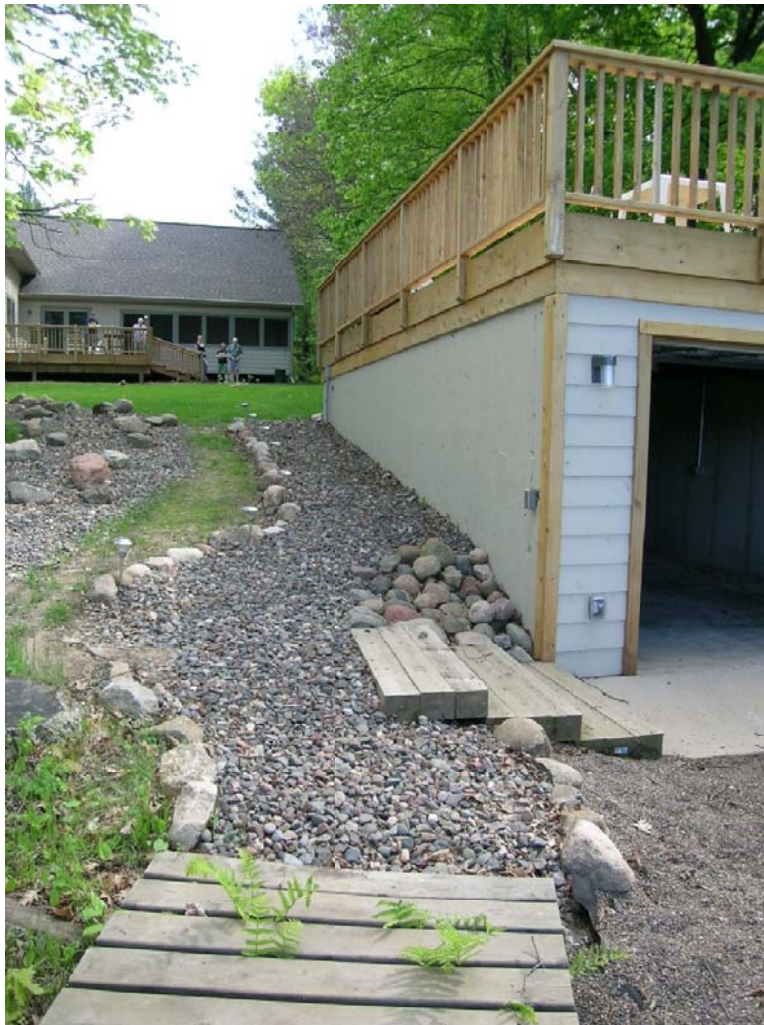
ISSUE: With the construction of a new boathouse, there was a significant amount of impervious area that was added to the yard.

SOLUTION: A rock infiltration area was constructed along the length of the boathouse. With this, water from the roof is directed and collected in the spaces between the rocks. This serves as temporary storage until it can slowly soak into the soil instead of flowing directly into the lake. The rock surface also doubles as a pathway from the boathouse to the dock, minimizing the foot traffic that could compact the soil in the yard and decrease its infiltration capacity.
